St Mary's, Appleton, Norfolk by R.Harbord.
Published in The Round Tower September 2009.

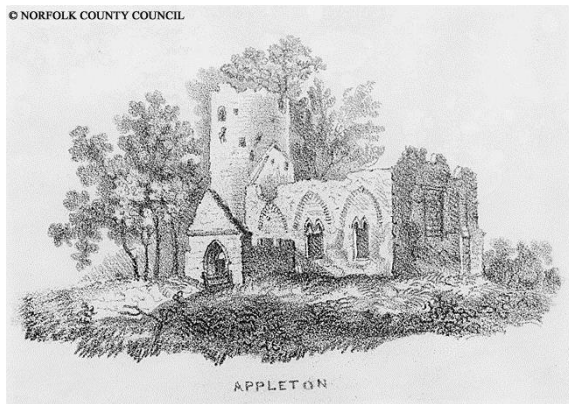
The *Domesday* Survey of 1086 lists a church and its glebe in Appleton, which may have existed before the Conquest. The tower is broad and has short thick walls. Robert Ladbroke drew the church from the south-east in the early 19th century. His sketch (above) suggests belfries each with twin openings under a round arch. The four arches have now gone but the circular middle column on the north, south and west sides survive. These are made up of about twenty, thin car-stones stacked about a metre high. The column is set back from the wall face and placed in the middle of the wall thickness. On the western side of the tower in the middle stage is a narrow slit window with a rounded head. It is capped by a large block of car-stone. All these features appear to be Norman in date. The inside of the tower is plastered above 2.5 metres with large sandstone blocks below. The same type of stones also appear externally on the north and south sides up to a similar height as well as in the west gable internally and externally. There are approximately square or rectangular in shape. How can they be explained? Were they robbed from a nearby Roman villa like the numerous red bricks and tiles inter-mixed with these stones? The change in materials probably reflects different building phases but they seem to have been generally all of one historical period. The upper third part of the tower tapers in diameter externally. There are no fillets between tower and gable wall.

quoins and a buff brick string-course below the gable. Inside, the large stone blocks seen in the tower and west gable are again visible. There is also a medieval *stoup* that appears to be reused from elsewhere. The external features described above can be seen in *Ladbooke's* drawing. Three members of the Paston family were buried in the church in the late 17th century but the last priest to be presented there was in 1705. At some date a lead roof was installed on the nave and porch. When this was stripped off, all fell quickly into decay. By the 1770s the access door had gone and the building was occupied by livestock (*Blomfield*). The infill walling inserted in the late 1500s had also disappeared.

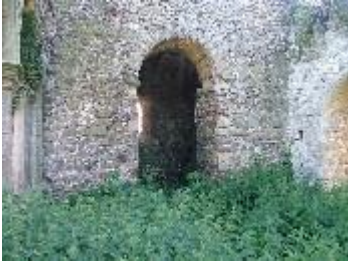
The tower arch is tall and narrow. It has sandstone and Roman bricks in the jambs. The stone impostes are decayed but there was no inset in elevation at the spring point of the arch. The tilting stone *vousoirs* are laid 'Escomb style' without using a key-stone at the top of the arch. This too could be an early Norman feature. There is no sign of an upper opening between this arch and the eastern belfry, blocked or otherwise. The upper half of this wall, facing east is coursed with smaller stones than below. The north wall of the nave survives. It is built of a third material - white chalky *clunch* so it may have been rebuilt long after the tower was erected. It is similar in thickness to the west wall of the nave, which adds to the conclusion that the nave predates the tower. The first priest was appointed to the church in 1310, which may have been when a small north door with a pointed head was inserted. It has chamfers with a hollow mould. At the same time a lancet window was inserted into the lower western part of the tower also with a sandstone frame. Neither the door nor window has a weather hood. All three openings on that western side of the tower are vertically aligned.

Tower arch, 1.35 thick; 1.65 wide by 2.47 to the imposts; 3.40 to the arch.
