Brandiston, St Nicholas by Stephen Hart

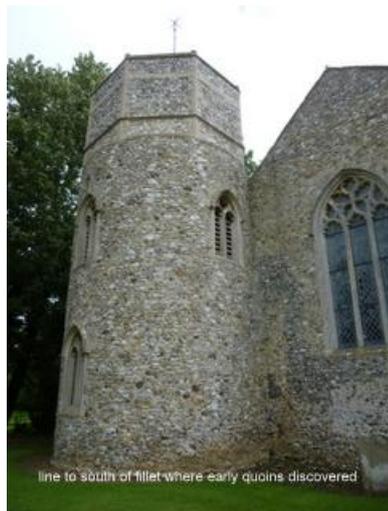
In 1994, a filled vertical crack in the nave west wall about half a metre to the south of the quadrant fillet in the re-entrant angle between the tower and the nave west wall (Photo 1) aroused the author's suspicion that it might represent the point at which the later nave had been joined to the west wall of the original one, particularly as there was also a vertical plaster crack in a corresponding position internally. In confirmation of this suspicion, during repairs to the nave west wall south of the tower carried out in 1996, corner quoins of flint and Roman bricks to a height of about 2.7m were found 10 to 12cm behind the wall's facing flints at a point approximately 0.5m south of the quadrant fillet. The position of this quoin implies that the original nave would have been rather wider than suggested by the alignments of the arcade and the present north wall.

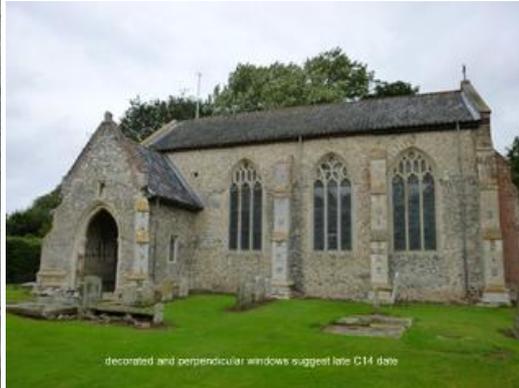
The nave and chancel of the same width comprises four bays, the easternmost being the chancel of the three-bay nave (Photo 2). Remnants of a blocked priest's door in the present east bay of the south wall suggests that this bay (now the chancel) may have been the west bay of a two-bay chancel, and scarred flintwork externally at the east ends of the south wall and to a lesser extent the arcade wall indicates that those walls probably continued eastwards as the walls of a longer chancel than the present one. Repairs incorporating medieval brick in the south wall east of the central window and in the flank of the adjacent buttress could imply reinstatement following removal of a former rood stair structure. The brick "footings" that extend from the buttresses at the east end are untrustworthy as an indication of the plan of a former chancel and may simply represent someone's fanciful conjectural restoration.

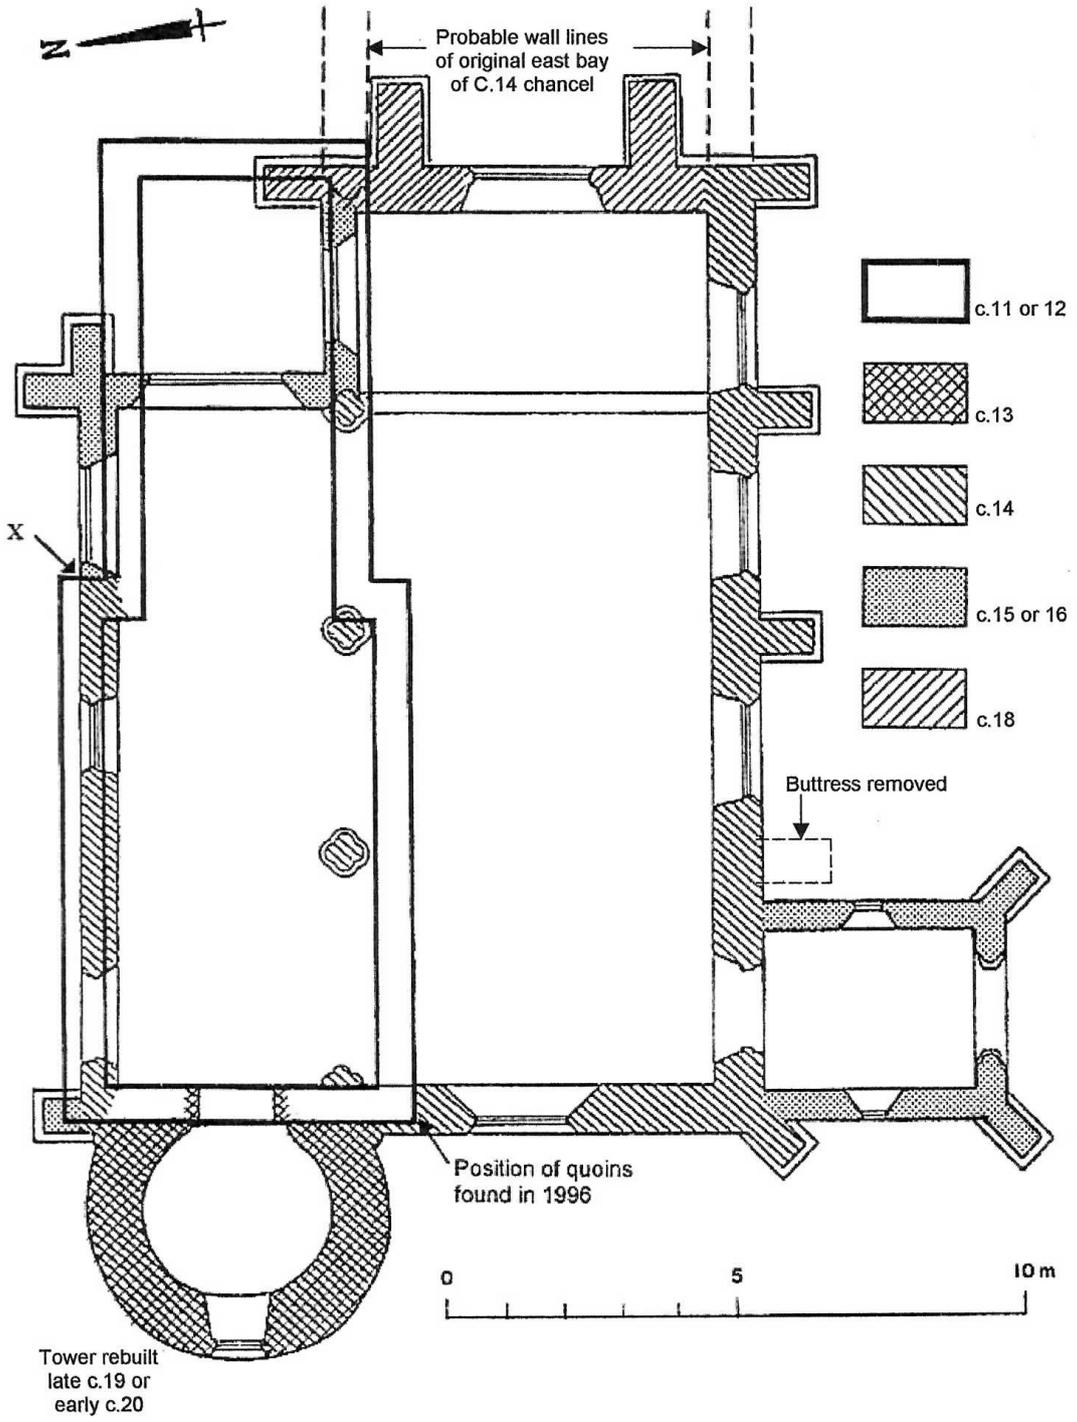
BRANDISTON CHURCH, PLAN

Phase 1. The SW quoin of flint and Roman bricks discovered in 1996 suggests an 11th or 12th century date for the original church. A two-cell plan, shown by thick lines on the plan, is suggested by the salient angle of flint and medieval brick at Point X, which, though not now part of the original nave north wall, probably indicates the position of its NE corner at a set-back for an original chancel narrower than the nave. The two eastern bays of the later arcade (see Phase IIIA below) indicate the probable length of that chancel.

The conjectured layout and measurement of the original church have been derived as follows: Original nave width. On the evidence of the deduced alignments of the original north and south walls of the original nave, and assuming north and south wall thicknesses to have been the same as the west wall measured at the tower arch (probably the only section of original fabric remaining) as shown on the Plan (Fig 1) an internal nave width of about 4.6m (15ft) would result.

Original nave length. If the flint and brick quoins of the present aisle north wall at Point X indicate the position where the inset at the junction of the original nave and chancel north walls occurred, as seems likely, that would establish the nave length. It would give internal nave length of about 8.1m (26ft 6ins).

Original chancel width. Assuming the wall inset at the nave-chancel junction to have been about equal to the wall thickness, the chancel width would have been about 3.25m (10ft 8ins). It would probably be possible to clarify this and establish the original chancel wall thickness by excavation or by resistivity measurement east of the present buttressed NE corner of the aisle.

Original chancel length. It has been shown above that the blocked east arch of the 14th century nave arcade must have given access to the original chancel. If the east respond of this arch had been of a similar design to the one at the west end of the arcade, that would establish the position of the original chancel's east wall, which would give internal chancel length of about 7.7m (25ft 3ins).
