Syderstone, St Mary's by Stephen Hart.

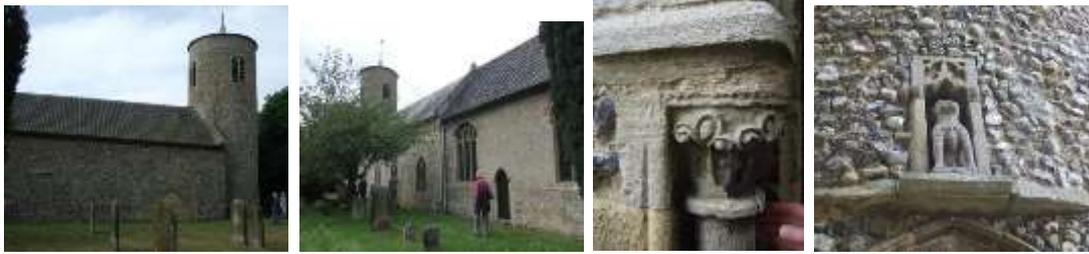
North and south sides, impost and niche above door.

The west door into the tower is of artless and confusing construction. Its pointed arch appears to be a different build from the jambs. The continuous stonework of the inner order of the opening has a hollow chamfer on the jambs which is not continued on the arch, and the chamfered impost – a Norman type though not uncommon also in early pointed doorways – seems to have been set upside down and support strange-looking springer blocks. The hoodmould, of a different stone, is oddly terminated. Colonnets of the outer order of the jambs have small stiff-leaf capitals, a definite Gothic feature seemingly later than the square capitals of the south arcade arches. The arch itself does not appear to be a reconstruction of (a) round one because the curvature radius of its voussoirs, if used in a semi-circular opening, would form a considerably wider doorway than is normal for an entrance door. Incisions in the stones that form the capitals of the shafts are unlikely to be scratch dials in such positions immediately below projecting impost and so do not prove that these stones were once on the south side. Has the O.S. benchmark been mistaken for a scratch dial?

The statue niche over the door is probably a later insertion and its canopy appears to be the head of a flushwork panel minus its flint infill. A notable feature of this tower is that it has no windows below the belfry.
