Rushmere, St Michael's by Stephen Hart

Architectural description

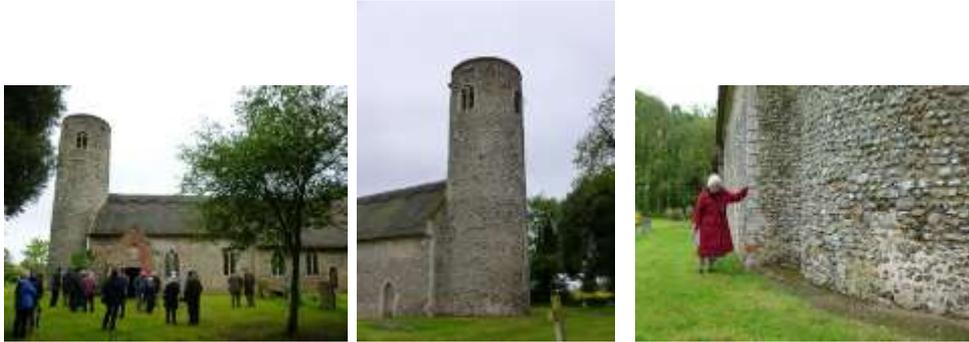
Tower, coursed flintwork and Caen stone quoins

The tower is circular to the top and can be seen to be in three distinct stages, clearly defined by differences in the flintwork of the walls. The lower stage, from the base to about 9ft above the ground is of coursed rubble flintwork similar to the nave north wall; the middle stage which occupies more than half the tower's total height is of more closely-packed uncoursed flints and contains a few medieval bricks; the belfry stage, surmounted by a shallow brick parapet, has coursed flintwork containing

medieval bricks which course with the flints and in places are laid in short consecutive stretches.
