## Barsham, Holy Trinity by Stephen Hart

### Architectural description

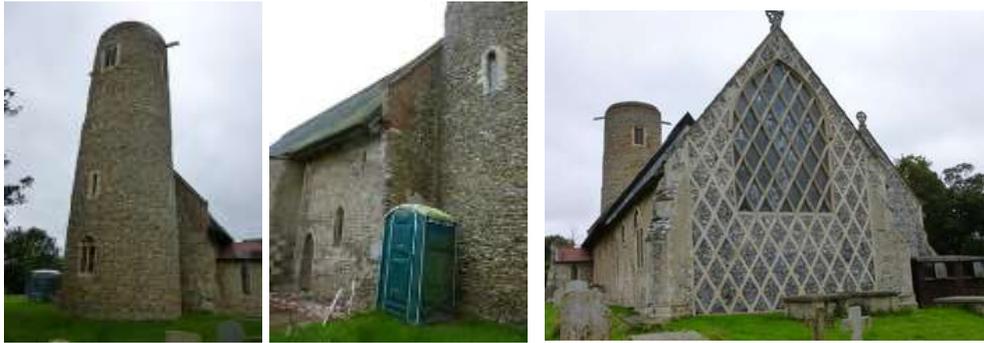
*Tower, quoins in nave west wall, north wall with Norman window, and east chancel wall.*

The church consists of a thatched nave, chancel with a tiled roof, north aisle, south porch and a round west tower. The western nave quoins of flints and erratics show that the nave is probably the oldest part of the church dating perhaps from the 11<sup>th</sup> century. It has a small Norman window in the north wall, and at high level in the nave west gable a double-splayed round-headed window exposed after a fire in 1979 indicates that the church was originally without a tower.

The chancel is notable for its extraordinary east end. The tracery of the east window is a diagonal lattice of mullions over the whole window and this pattern is extended as flushwork covering the rest of the wall. No certain date has been established for this but it has been interpreted as a rebus of the shield of Sir Edward Etchingam, the patron of the church in the 16<sup>th</sup> century.

The round tower has variously been attributed as Saxon or Norman but there are convincing arguments and evidence to show it is probably post-Norman. It is circular to the top and is in three stages: the lower stage occupies just over half the height and terminates at an offset ledge in the wall at approximately the level of the nave roof apex; the middle stage, about 9ft high rises from the offset to about 2ft below the cills of the belfry openings, and the top stage comprises the belfry and the parapet.
