## Old Catton, St Margaret's by Stephen Hart

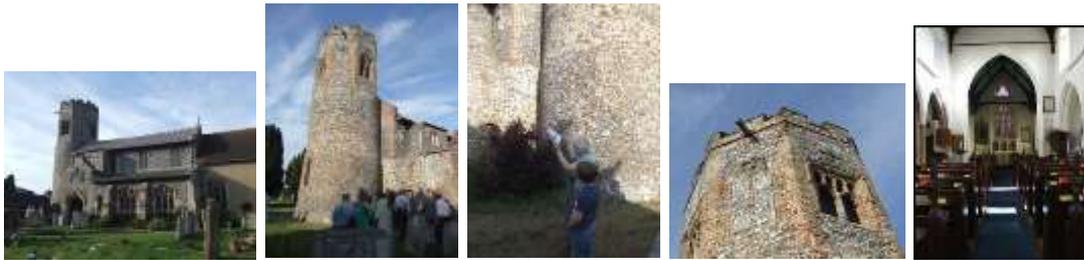
*Tower and west wall. Tower arch by Simon Knott*

The tower is circular for roughly two-thirds of its height and has an internal diameter of 10ft 9ins, its wall is 3ft 11ins thick measured at the ground-floor west window, and its east wall is curved internally. There are no fillets in the re-entrant angles between the tower and the nave west wall, nor is there any continuity of the flintwork where they join.

Measured at the apex of the tower arch, with overall thickness of the wall between nave and tower is 3ft 4ins but this thickness consists of a double arch comprising a 2ft 6ins thick one through the nave west wall and behind it, a taller one 10ins thick

formed in the curvature of the tower's east wall. The nave-side arch is pointed with a moulded profile, the moulding dying into plain splayed jambs without impost; it is 3ft 10ins wide and 7ft 11ins high to the apex. The rere-arch on the tower side is the same width but 9ft 4ins high with a plain depressed pointed head. The pointed shapes of both arches show that they are post-Norman despite a suggestion that they may have been altered from round-headed ones for aesthetic reasons; there is, though, no evidence of this, and even if the nave-side arch had been altered (possibly having originally been a west entrance), there seems no reason why the rere-arch in the tower would have been. With a post-Norman tower arch, the tower is unlikely to be earlier.
